OCEAN NETWORKS CANADA

**ENDEAVOUR
MOTHR
OVERVIEW
JULY 2023**

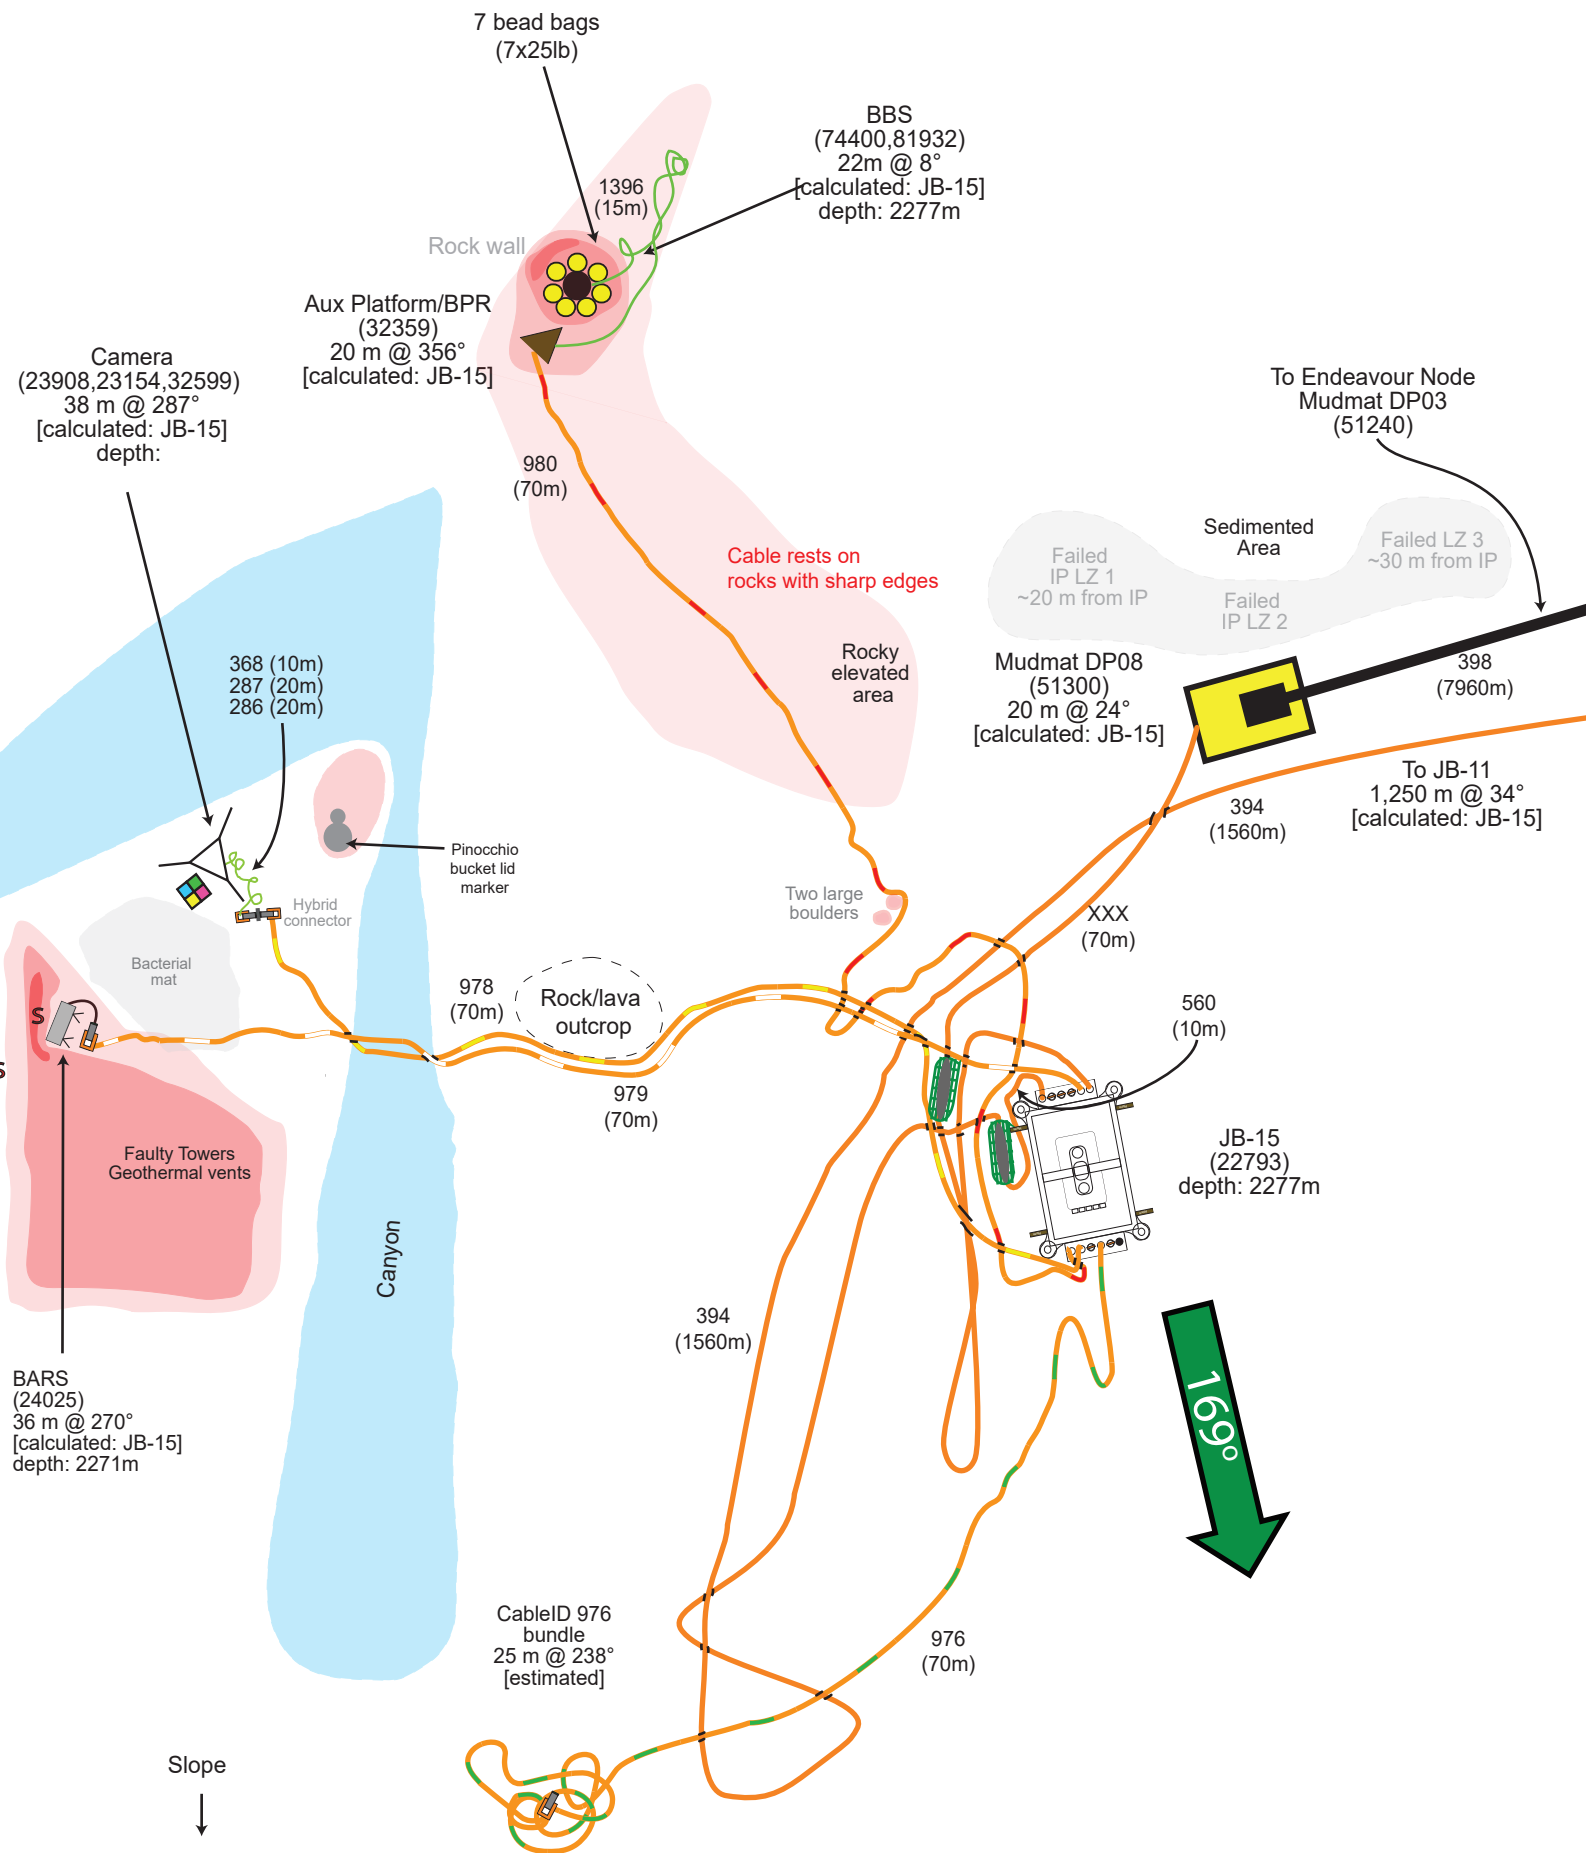
- Site needs to be re-layed out. This diagram is stitched out of multiple dives, each one showing only small part of this site. Please fly over cables with ROV and JB-15.
- If time allows, more flying around mudmat required.
- Media Converter and Mudmat (NEPDATA-23654)
- Port J7 on JB-15 is faulty - very likely compromised
- It looks like there are two media converters on cable 560, but very likely the further one is rather on the cable that goes to Endeavour Node Mudmat
- Position confirmation for the mudmat
